# KEKANA ESKOM: Wetland Baseline and Impact Assessment

*Prepared for:*  
**NSOVO ENVIRONMENTAL CONSULTING**

*Prepared by:*  
Willem Lubbe  
for  
**WaterMakers**

**June 2024**

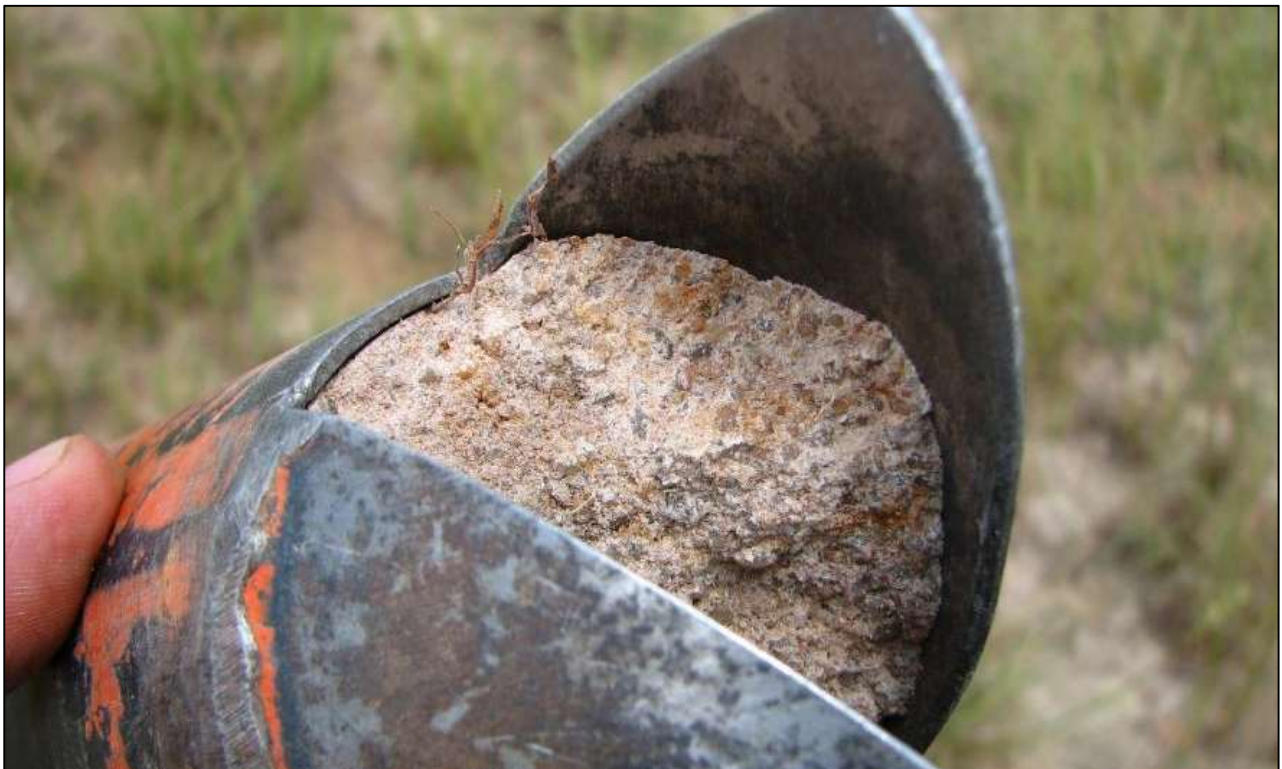
Photograph 1: Remaining bottom portion of E-horizon with some orange mottles visible within a sand mined area

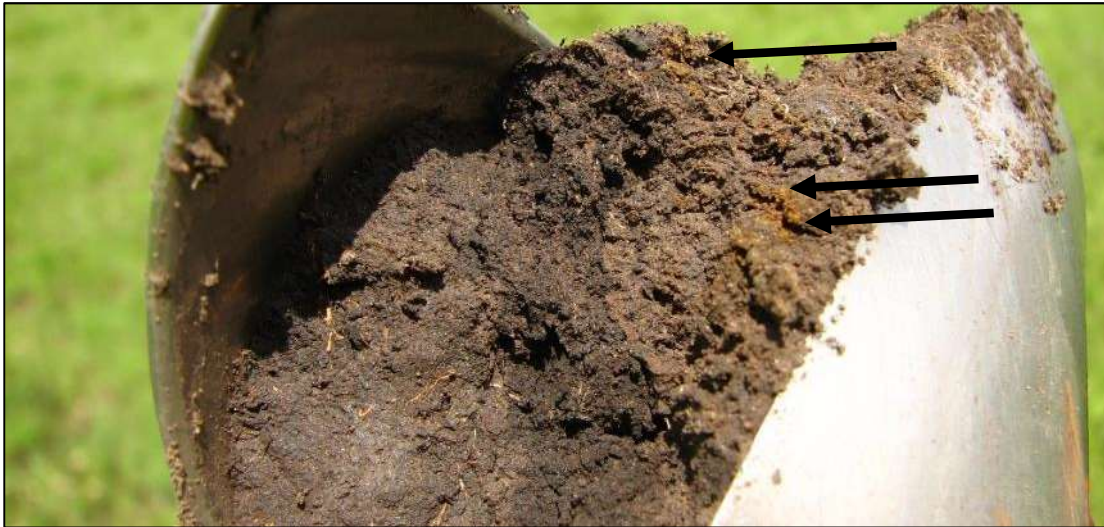
Photograph 2: Orange mottles (indicated by arrows) within a reduced matrix of a valley bottom wetland of the study area. Also note the reduced matrix indicated by grey coloration

According to the DWAF (2005), soil wetness indicators (i.e. identification of redoximorphic features) are the most important indicator of wetland occurrence due to the fact that soil wetness indicators (redoximorphic features) remain in wetland soils, even if they are degraded or desiccated, in most instances. It is important to note that the presence or absence of redoximorphic features within the upper 500mm of the soil profile alone is sufficient to identify the soil as being hydric (a wetland soil), or non-hydric (non-wetland soil) (Collins, 2005). Several redoximorphic features were present within soil profiles of the delineated wetland areas, including black, orange and red mottles as well as rhizospheres (Photograph 2).

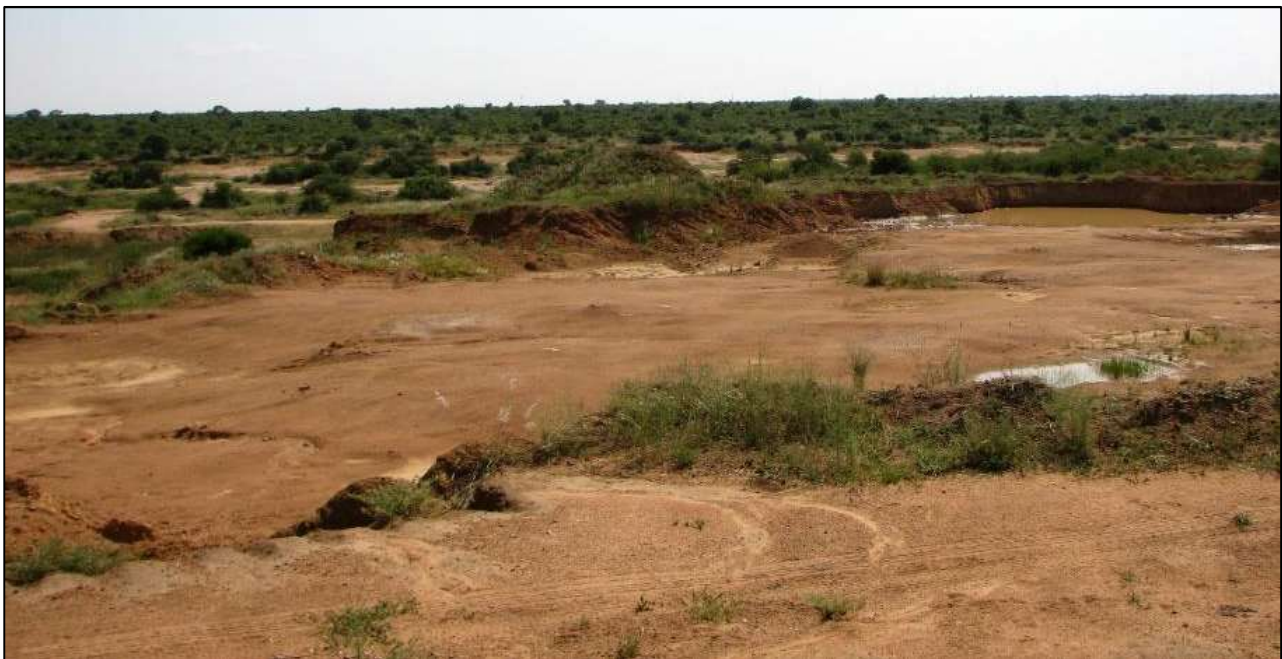
Photograph 3: Intensive sand mining operations in the north of the study area within HGM 1

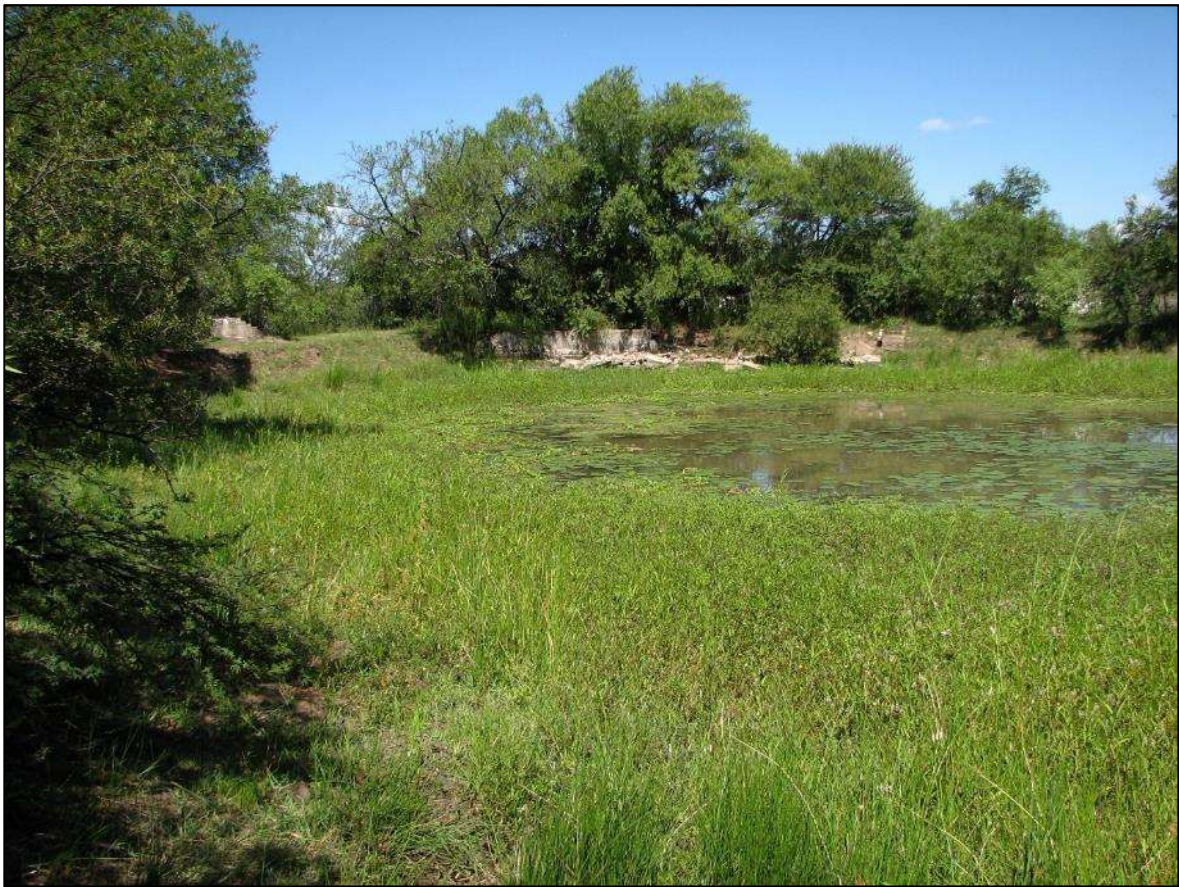
Photograph 4: Artificial dam on the periphery of *Spirostachys africana* (Tamboti) dominated hillslope seepage woodland.

This hillslope seepage system highest scoring eco-services attributes were maintenance of biodiversity, nitrate removal and streamflow regulation (Figure 8). The accumulation of organic matter and fine sediments in the wetland soils results in the wetland slowing down the sub-surface movement of water down the slope. This “plugging effect” increases the storage capacity of the slope above the wetland, and prolongs the contribution of water to the stream system during low flow periods (Kotze, 2005). Seepage wetlands are commonly considered to supply a number of water quality enhancement benefits, for example, removing excess nutrients and inorganic pollutants produced by agriculture, industry and domestic waste (Rogers *et al.*, 1985; Gren, 1995; Ewel, 1997; Postel, 1997). Hillslope seepages generally would be expected to have a relatively high nitrogen removal potential. Nitrogen and specifically nitrate removal could be expected as the groundwater emerges through low redox potential zones within the wetland soils, with the wetland plants contributing to the necessary supply of organic carbon. Particularly effective removal has been recorded of nitrates from diffuse sub-surface flow, as characterizes hillslope seepages (Muscutt *et al.*, 1993). From a biodiversity perspective HGM 14 represented a rather unique wetland being dominated by *Spirostachys africana* (Tamboti) woodland which could potentially provide habitat for fauna and flora species of conservation concern based on the wetlands intact nature (Photograph 4). Wetland functionality in
